# The Ffrwd Branch

## History of the Ffrwd branch canal

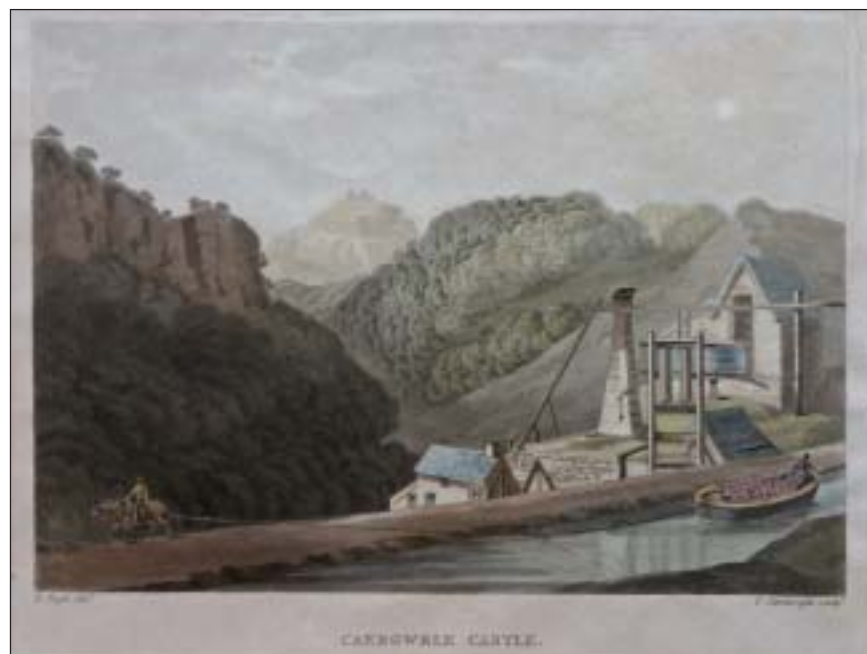
The hand coloured aquatint reproduced below, painted by Edward Pugh and published in 1815 in *Cambria Depicta*, a volume of illustrations of North Wales, implies that it was used by at least one boat. But how accurate was this picture?

The canalside colliery owned by Richard Kirk was at Ordnance Survey map reference SJ305550. This location is consistent with the angle between the line of the canal and the sight line to Caergwrle Castle. The mine buildings depicted are certainly not fanciful, though they appear to be a compilation of elements rather than an accurate representation.

However, the scene is nothing like as dramatic as depicted — it is extremely exaggerated in vertical scale and much altered in basic appearance. The slope in the foreground is nowhere near as steep. Indeed this is a side valley, not the valley of the Cegidog (which certainly is steep). The valley should curve round to the right much sooner than is shown, and there should be a ridge running across the centre, rising to the left, over which the castle can just be seen. There are no cliffs on the left hand hill; indeed there are no crags like that on any hill nearby. The right hand hill is actually the wooded flank of Windy Hill, round which the canal ran. Only the top of the castle hill can be seen, and actually there should be another hill immediately to its right.

was made to appear as dramatic and exotic as possible. Heights were exaggerated, valleys were deepened. Artistic impact and compositional balance were far more important than accuracy — here the eye is guided towards the castle in a way which is contrary to the true lie of the land. The mine is included purely for foreground interest. Similarly, the horse and the boat strengthen the composition.

Caergwrle Castle, the subject of the painting according to its title, would indeed have been just visible between the slopes of the hills

on either side. This is confirmed by constructing a profile: the canal is 118 metres above sea level, the castle 135m and the shoulder of the hill roughly half way between the two is about 115m. It is not now possible to take a photograph from exactly the same place which shows the castle because trees have grown up, both in the foreground and on the shoulder of the hill between the viewer and the castle.

Assuming the boat is meant to be taking coal from the mine to the coal yard by the Moss-Gwersyllt road at the south end of the canal, it is going in the wrong direction.

So much of the picture is 'artistic licence' that in my opinion it does not provide evidence that boats ever used the canal, or even that it was in water here. The verdict remains 'not proven'.

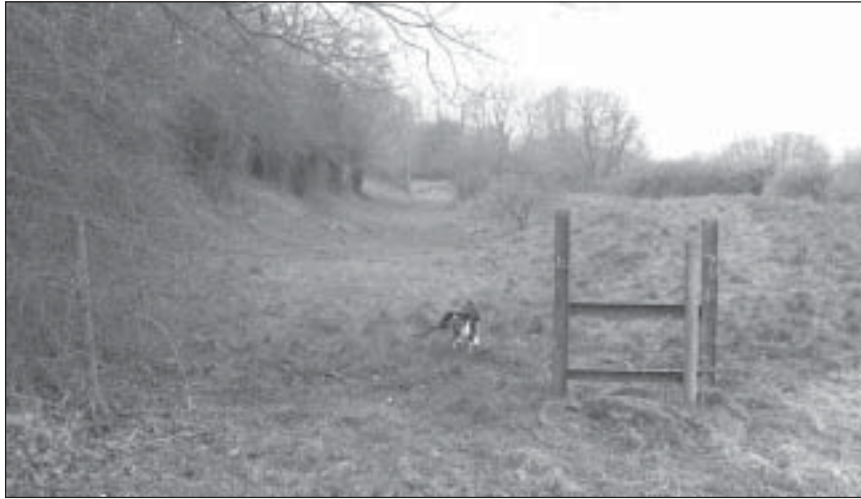
*The profile of the canal, with a flat bottom to the channel, sides sloping at about 1:2, and a towpath on the downhill side. The method of construction whereby the left hand side of the channel is dug into the hillside and the material used to build up the towpath on the right as an embankment can be seen clearly.  
(SJ308555)*

At the end of the hedge is another stile; climb over this, then continue along the edge of the field, keeping the hedge on your left. Shortly you come to another stile — and the remains of the canal in front of you are very clear. This is a typical narrow canal, with a flat bottom to the channel, sides sloping at about 1:2, and the towpath on the downhill side. The towpath can be walked for about a quarter of a mile. Towards the end we found much of the line of the canal still in water, though the railway in a cutting to our right was (relatively) dry. This shows how effectively the canal was puddled.

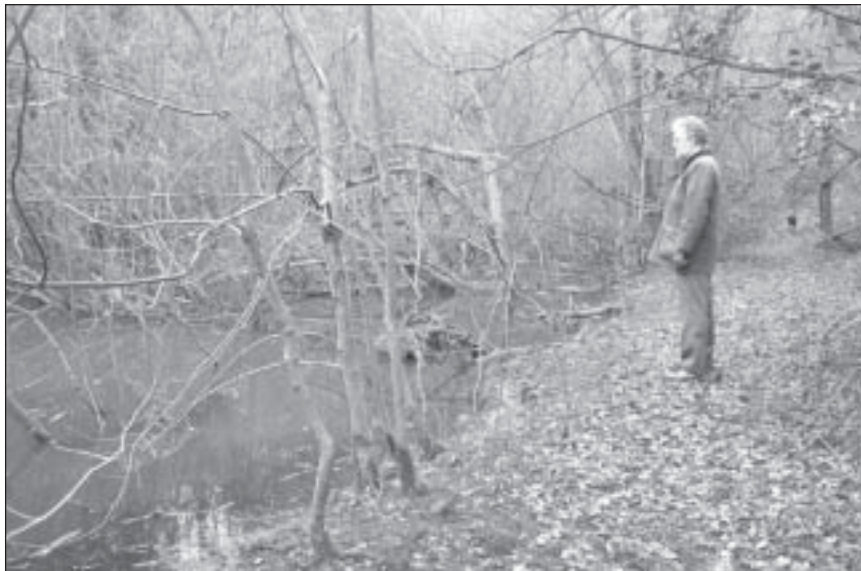
*Despite being unused for over 200 years, some of the length of the canal was still in water.  
(SJ306551)*

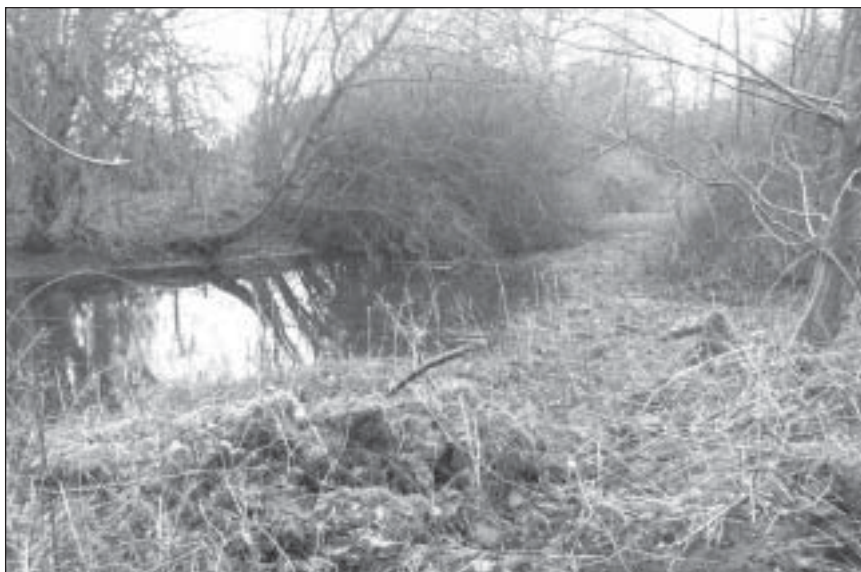
*The terminal basin of the canal at Ffrwd. In the foreground are the remains of a building. At the back, towards the right, the line of the canal may be seen.  
(SJ302546)*

The other place where the canal's remains can be examined is at the hamlet of Ffrwd. Cars may be safely parked near the road junction (SJ 300547). Opposite the junction a footpath crosses a stile. A few yards further on is an abandoned colliery shaft — from there, if you look over to your left you will see what looks like a pond. This was the terminal basin of the canal. Alongside it, a moss-covered pile of stones, bricks and tiles reveals the site of a small building, possibly canal-related.
